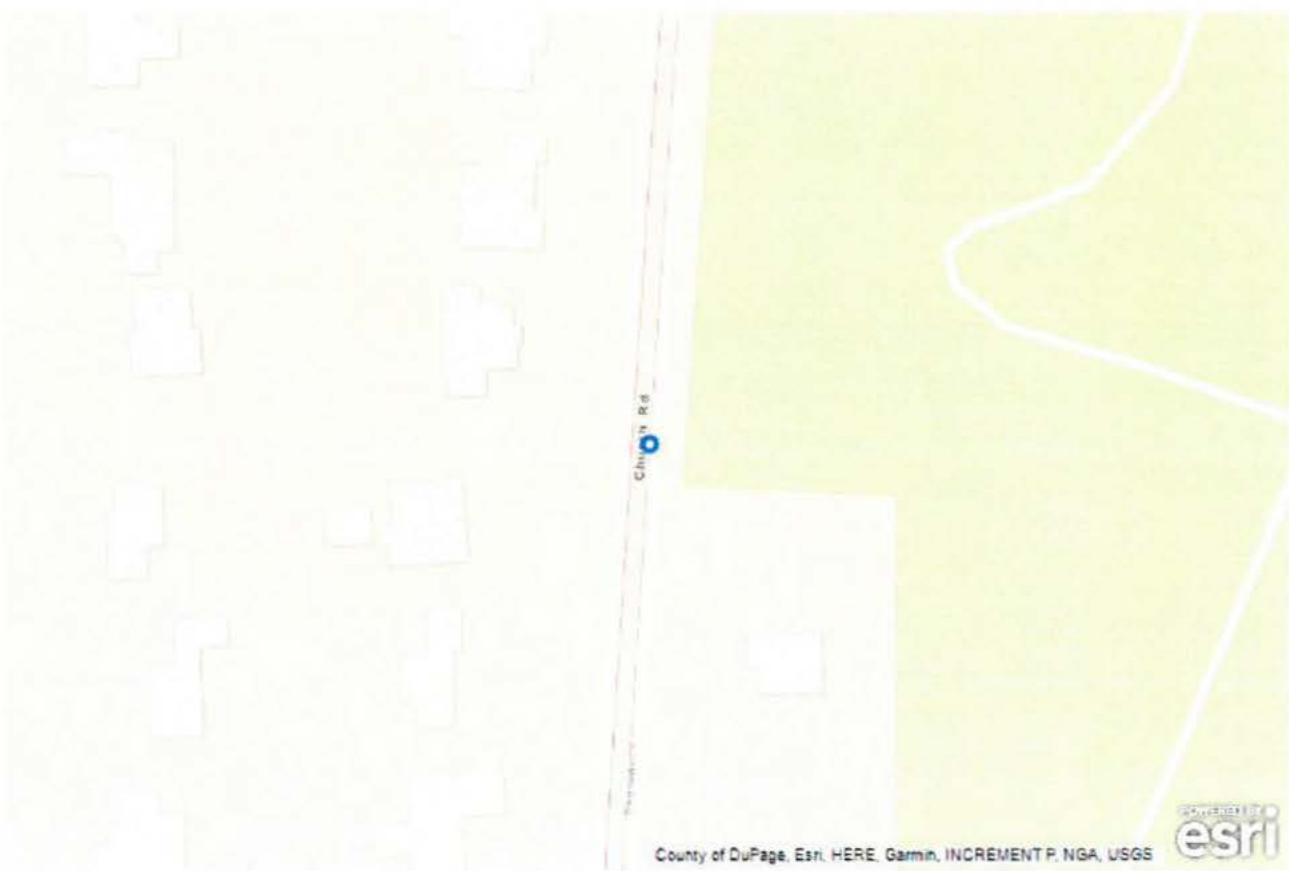
Task ID	Activity	Asset
1749	Repair	Water Hydrant 029691
Status	Completed	Start Date 10/17/2016
Priority	Medium	Stop Date 10/17/2016
Notes	Old eddy Got hit 5-19-16 Trine installed new mueller hyd

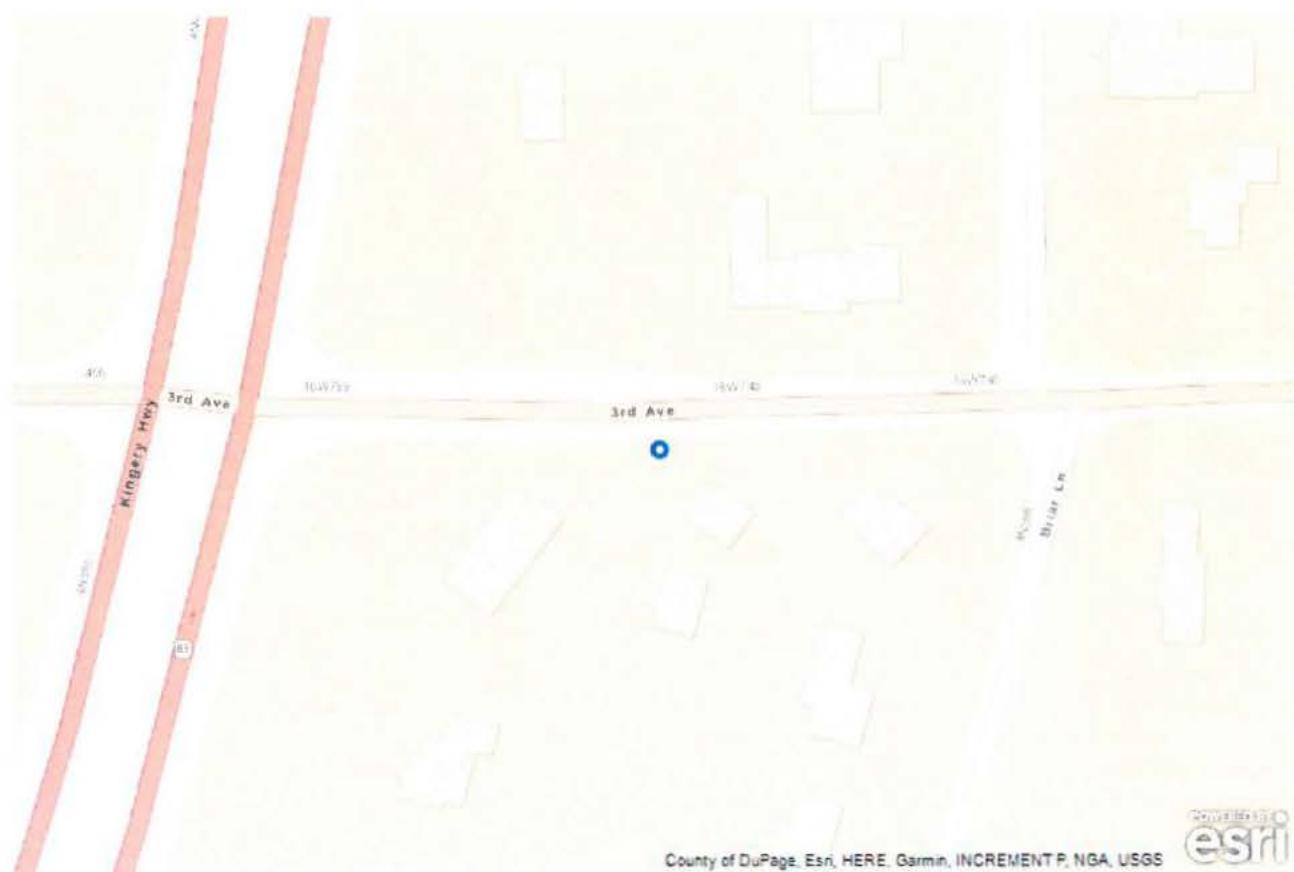
Notes Repair/replace hydrant
currently not working on white pines infrastructure

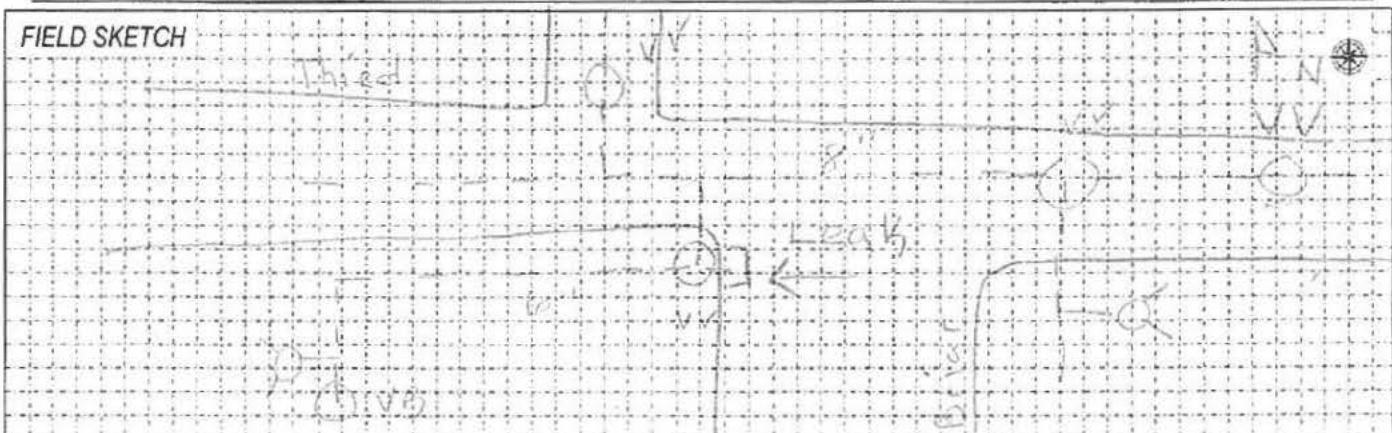
LOCATION OF LEAK: SW Third & Broad; the tank shows up @ the North 6" Valve in Vault @ this location.

LEAK DESCRIPTION: (size of orifice, repair method) Village Pumped out Valve. No signs of the leak, leak is on capped end of water main

RECOMMENDED ACTION: Village to take further action

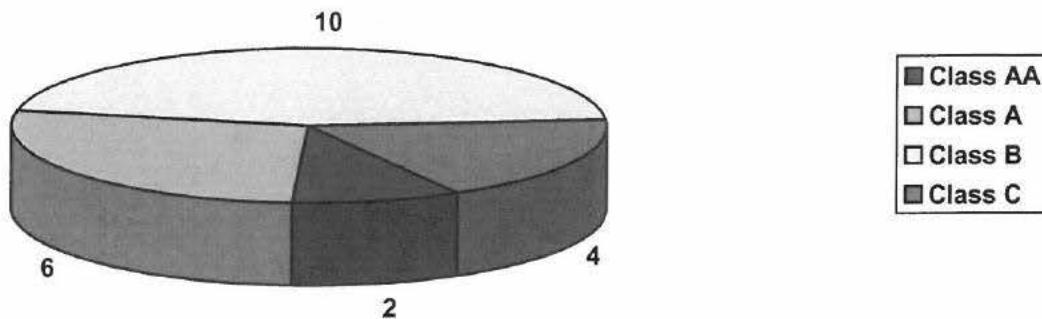
Twenty-two (22) hydrants are classified in the 2015 Hydrant Flow Program. Two (2) that were classified are classified "AA". Six (6) is classified "A". Ten (10) are classified "B". Four (4) are classified "C".
