Re: September 28, 2018 FOIA Request

*"Residents present asked that District No. 1 secure information from the Village and/or Fire Protection District No. 2 (whichever is best able to answer) as to the servicing, maintenance, repair, and out of service hydrants serving White Pines Subdivision for the years 2000, 2001, 2002, 2003, 2004, 2005, 2006, 2007, 2008, 2009, 2010, 2011, 2012, 2013, 2014, 2015, 2016, 2017, and 2018 to date."*

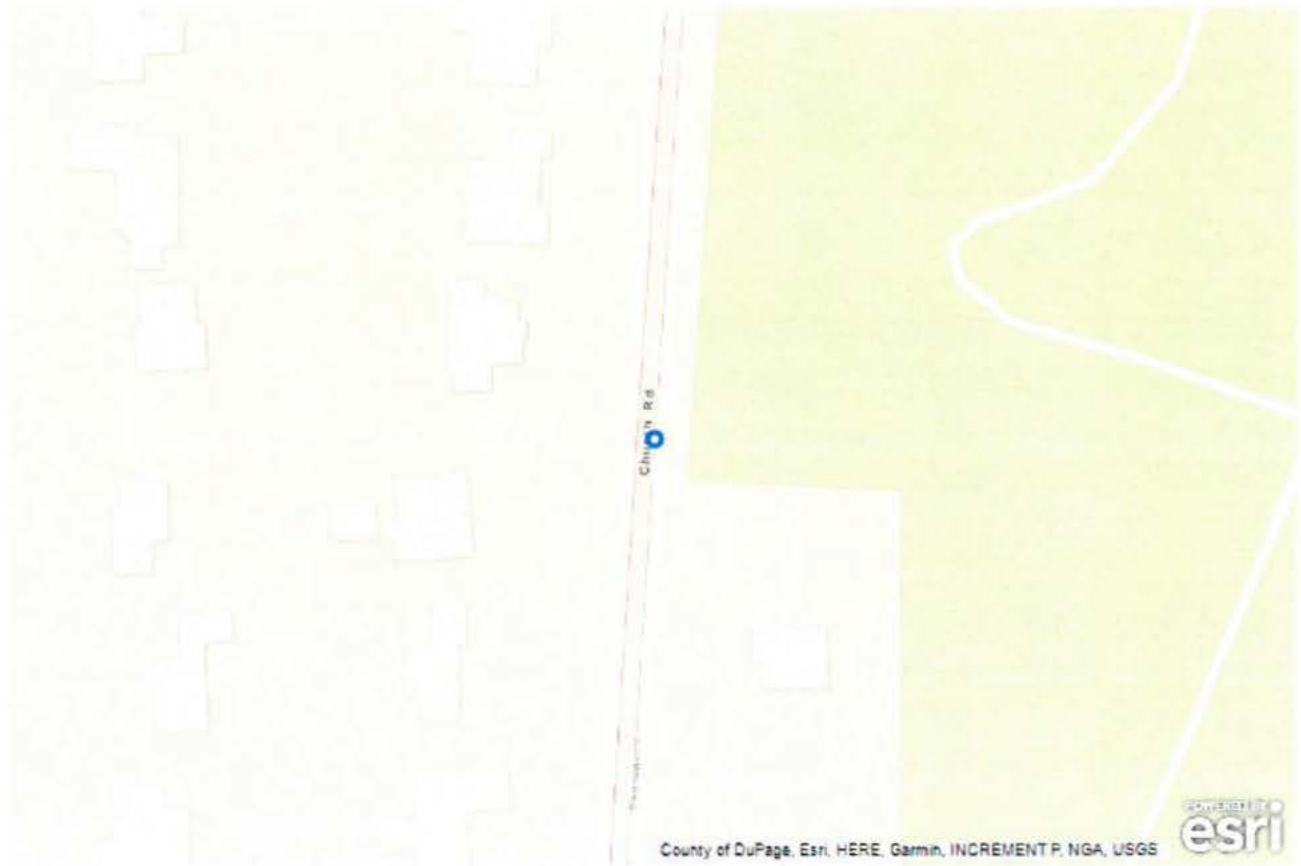
| Task ID | | Activity | Asset |
|---|---|---|---|
| 1749 | | Repair | Water Hydrant 029691 |
| Notes | Old eddy<br>Got hit<br>5-19-16<br>Trine installed new mueller hyd | | |

| Description | Vendor | Usage | Cost |
|---|---|---|---|
| Trine installed new hyd | | 2.00 hr | \$0.00 |
