At 1434 hrs. Chief Mike Spain called me and asked that I respond to Aaron Equipment at 735 E. Green St. where they treated and transported 2 burn victims from an explosion.

735 E. Green Street
PHOTO LOG

Explosion and Fire With Injuries
7/13/2018

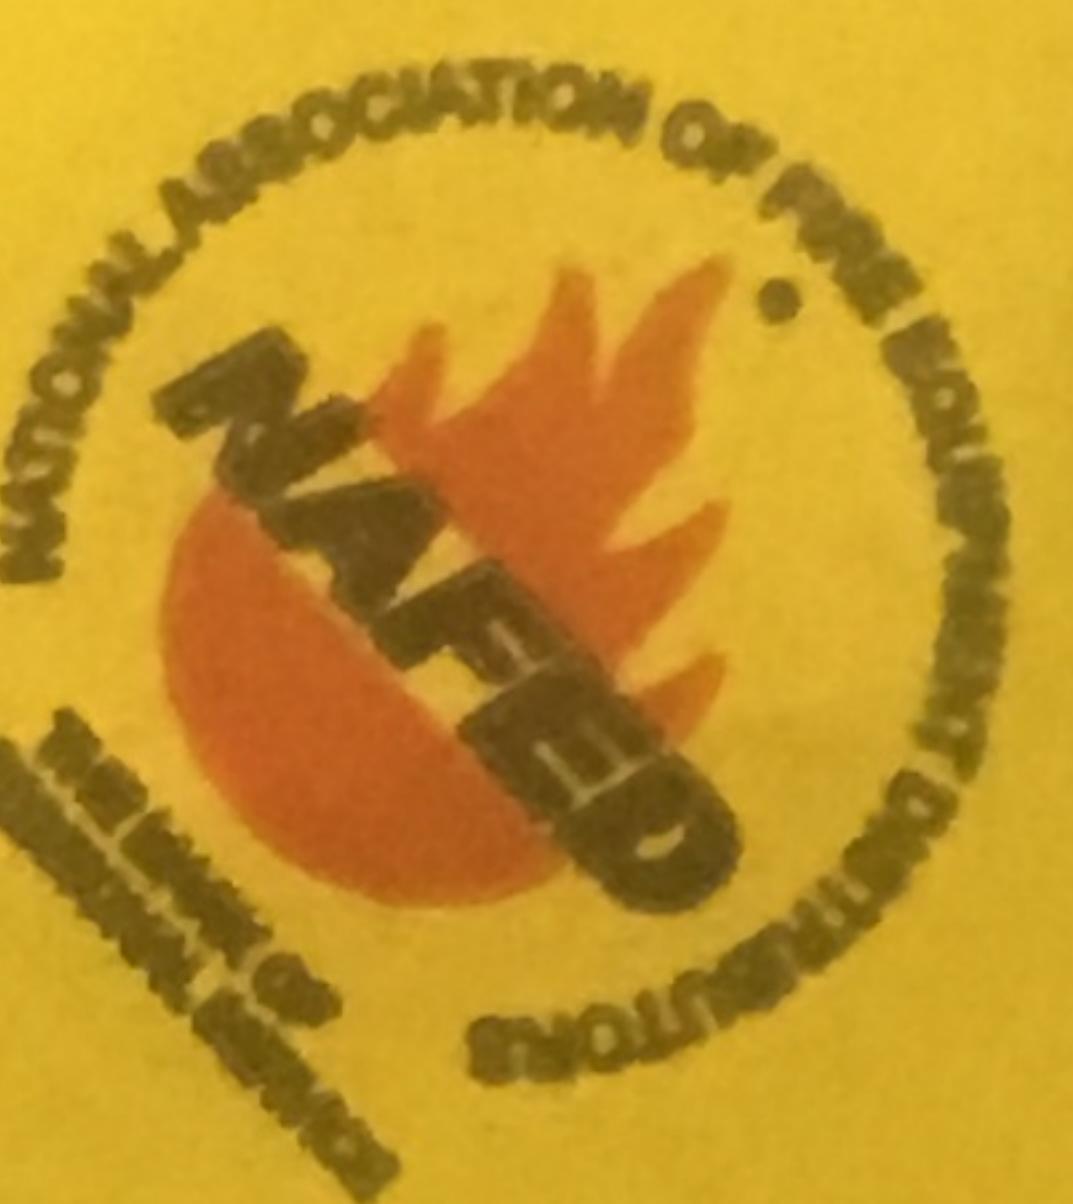
CERTIFICATION TAG

VOID 1 YR. FROM MO. PUNCHED: SYSTEMS 6 MOS.
