Re: Freedom of Information Act Requests

# All Hydrants

M.E. Simpson Co., Inc. is pleased to submit this report on the fire hydrant flow testing project for the Village of Bensenville, Illinois, conducted by our crews on April 10, 2014. Fire-flow tests are conducted to determine pressure and flow-producing capabilities at any location within the distribution system. Primarily, the tests determine how much water is available for fighting fires; however, the tests also serve as a way to determine the general condition of the distribution system. The tests can point to an area of the distribution system that may have lower flow-carrying capacities due to tuberculation of the pipes or perhaps a closed valve. The testing also allows inspection and maintenance to occur on a regular basis.

## Fire Hydrant Flow Testing Results

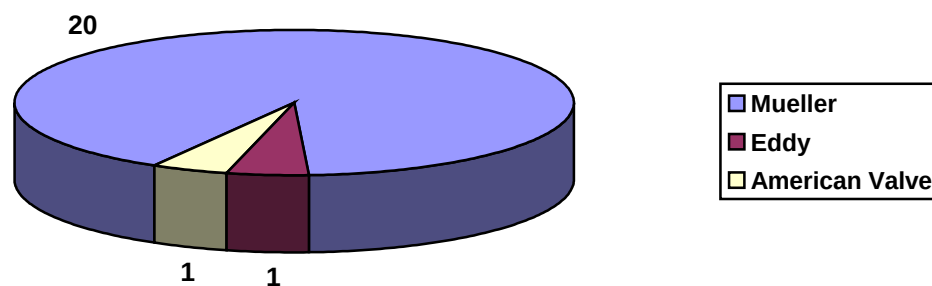
M.E. Simpson Co., Inc. located and inspected twenty-two (22) hydrants for the Village of Bensenville. The brands of hydrants varied slightly. 20 (90%) are Mueller hydrants. 1 (5%) is an American Valve hydrant and 1 (5%) is an Eddy Hydrant.

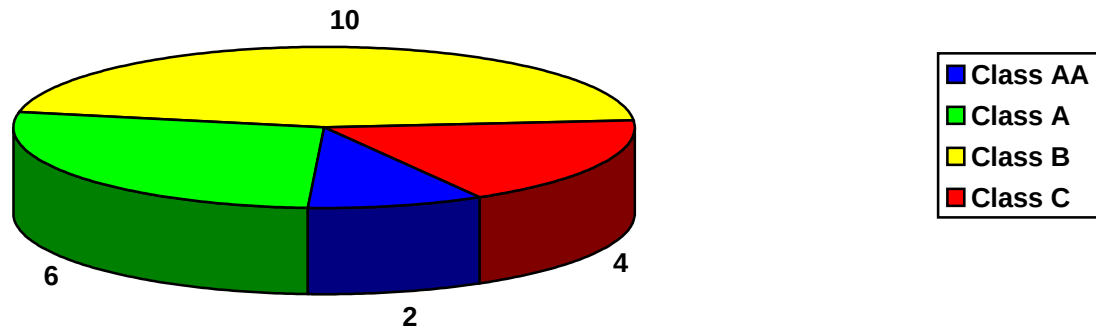
The National Fire Protection Association (NFPA) uses flow capacity to classify hydrants. Any hydrant with a rated capacity of 1,500 GPM or greater is classified "AA" (color - Blue). Any hydrant with a rated capacity of between 1,000 and 1,499 GPM is classified "A" (color - Green). Any hydrant with a rated capacity of between 500 and 999 GPM is classified "B" (color – Yellow). Any hydrant with a rated capacity less than 500 GPM is classified "C" (color - Red).

Twenty-two (22) hydrants are classified in the 2015 Hydrant Flow Program. Two (2) that were classified are classified "AA". Six (6) is classified "A". Ten (10) are classified "B". Four (4) are classified "C".

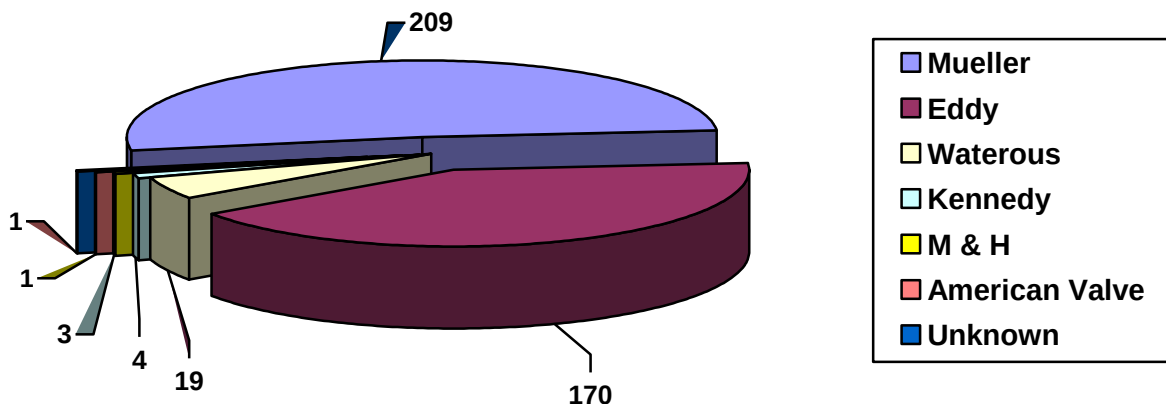
M.E. Simpson Co., Inc. located and inspected four hundred six (406) hydrants for the Village of Bensenville. The brands of hydrants varied slightly. 209 (51%) are Mueller hydrants. 170 (41%) are Eddy hydrants. 19 (4%) are Waterous hydrants. 4 (1%) are Kennedy hydrants. 3 (1%) are M & H hydrants. 1 (.5%) is an American Valve hydrant. 1 (.5%) hydrant's make was undetermined.

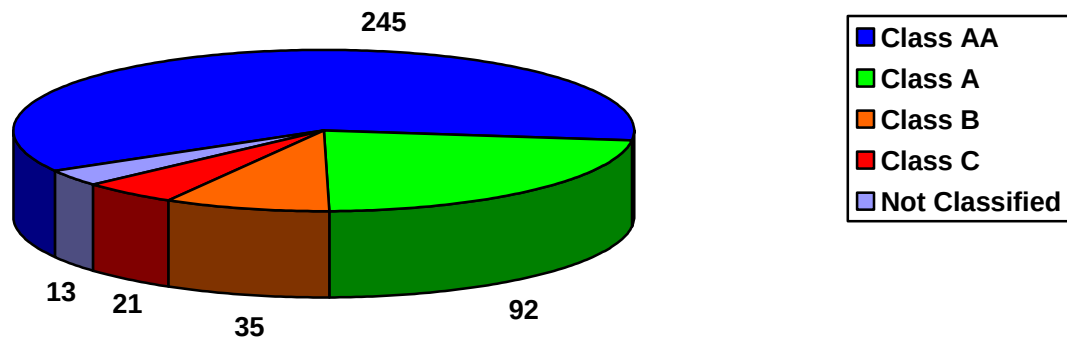
The National Fire Protection Association (NFPA) uses flow capacity to classify hydrants. Any hydrant with a rated capacity of 1,500 GPM or greater is classified "AA" (color - Blue). Any hydrant with a rated capacity of between 1,000 and 1,499 GPM is classified "A" (color - Green). Any hydrant with a rated capacity of between 500 and 999 GPM is classified "B" (color – Orange). Any hydrant with a rated capacity less than 500 GPM is classified "C" (color - Red).

Three hundred ninety-three (393) hydrants are classified in the 2015 Hydrant Flow Program. Two hundred forty-five (245) that were classified are classified "AA". Ninety-two (92) are classified "A". Thirty-five (35) are classified "B". Twenty-one (21) are classified as "C". Thirteen (13) are unable to be classified.

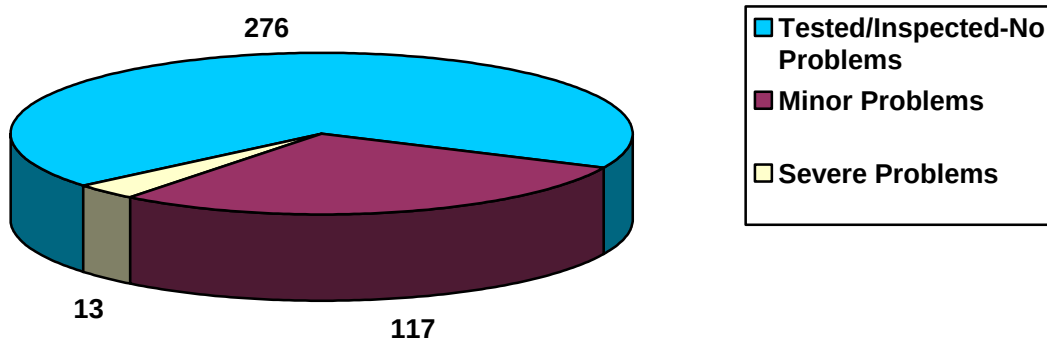
One of the most important outcomes of the testing program is the discovery of problem hydrants. In some cases, these problems could be dangerous. The problems that should be corrected first are on the Unusable-Severe Problem hydrants. If a hydrant cannot be opened or a pumper port cap cannot be removed that hydrant would be classified unusable. Some problems are easily correctable and not as serious as others, these hydrants are Usable-Minor Problems. One hundred seventeen (117) hydrants had minor problems. Thirteen (13) hydrants had severe unusable problems. There were only five (5) hydrants that drained slowly or did not drain at all.

Thirteen (13) hydrants were reported as Unusable-Severe Problem. One hundred seventeen (117) hydrants were reported as Usable-Minor Problem. Because these problems were reported as they were found, a comparison should be made between the problem lists and what has already been fixed. We recommend the proper repairs be made to the problem hydrants and the information be updated in the Pro-Hydrant® database.

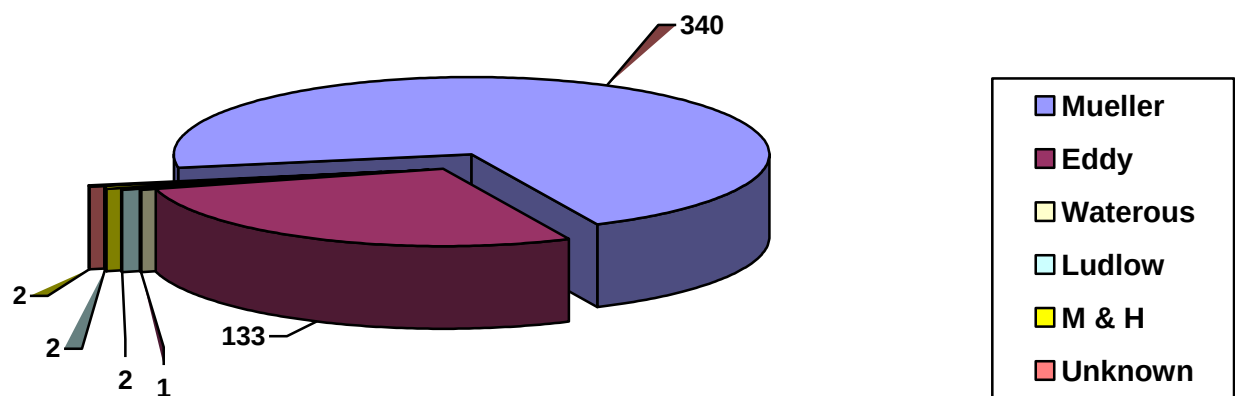
M.E. Simpson Co., Inc. located and inspected four hundred eighty (480) hydrants for the Village of Bensenville. The brands of hydrants varied slightly. 340 (71%) are Mueller hydrants. 133 (28%) are Eddy hydrants. 2 (Less than 1%) are Ludlow hydrants. 2 (Less than 1%) are M & H hydrants. 1 (Less than 1%) is a Waterous hydrants. 2 (Less than 1%) hydrants' makes were undetermined.

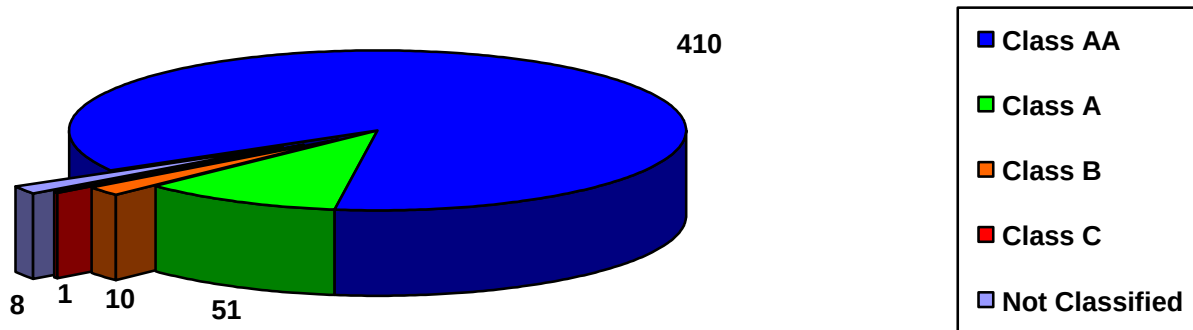
The National Fire Protection Association (NFPA) uses flow capacity to classify hydrants. Any hydrant with a rated capacity of 1,500 GPM or greater is classified "AA" (color - Blue). Any hydrant with a rated capacity of between 1,000 and 1,499 GPM is classified "A" (color - Green). Any hydrant with a rated capacity of between 500 and 999 GPM is classified "B" (color – Orange). Any hydrant with a rated capacity less than 500 GPM is classified "C" (color - Red).

Four hundred seventy-two (472) hydrants are classified in the 2016 Hydrant Flow Program. Four hundred ten (410) that were classified are classified "AA". Fifty-one (51) are classified "A". Ten (10) are classified "B". One (1) is classified as "C". Eight (8) are unable to be classified.

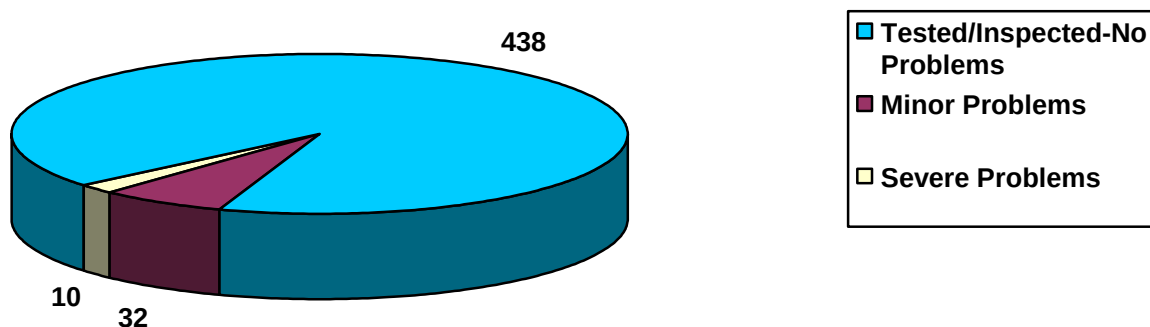
One of the most important outcomes of the testing program is the discovery of problem hydrants. In some cases, these problems could be dangerous. The problems that should be corrected first are on the Unusable-Severe Problem hydrants. If a hydrant cannot be opened or a pumper port cap cannot be removed that hydrant would be classified unusable. Some problems are easily correctable and not as serious as others; these hydrants are Usable-Minor Problems. Thirty-two (32) hydrants had minor problems. Nine (9) hydrants had severe unusable problems.

Nine (9) hydrants were reported as Unusable-Severe Problem. Thirty-two (32) hydrants were reported as Usable-Minor Problem. Because these problems were reported as they were found, a comparison should be made between the problem lists and what has already been fixed. We recommend the proper repairs be made to the problem hydrants and the information be updated in the Pro-Hydrant® database.
